## IN THIS EDITION

## NEW PRODUCTS

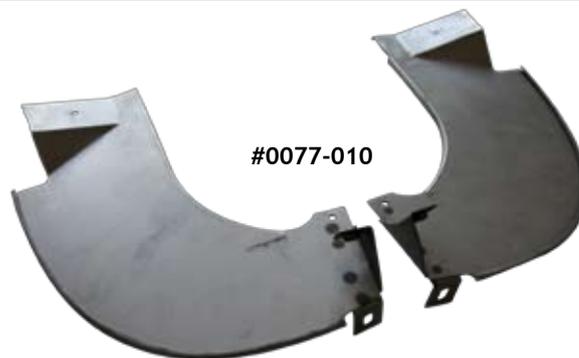
#0077-010

These bumper splash pans are assembled between the rear bumper and the corner of the body. These pans are mostly in a bad condition. The quality of the splash pans is excellent and with the 1.00mm steel used, they are the best available on the market. Together with our original seals (BBT # 0077-05) you can perfectly restore this part of your Type 2. Sold a pair for 1 car. Already some in stock.

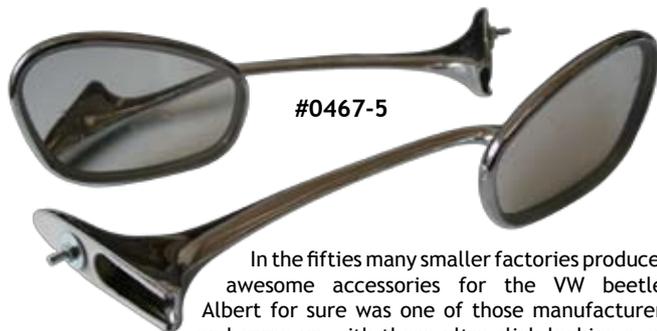
#0467-5

In the fifties many smaller factories produced awesome accessories for the VW beetle. Albert for sure was one of those manufacturers and came up with these ultra slick looking swan neck mirrors. Swan necks are mounted in the front of the chrome trim on the front inner fenders. These stylish rear view mirrors do add a big aerodynamic look to your car and are a perfect fit accessory for each beetle with wide mouldings. BBT stepped up and added high quality reproductions from these mirrors in to our program for you. The mirrors do come in a "BBT approved packaging" and are sold a pair. Available straight from our warehouse.

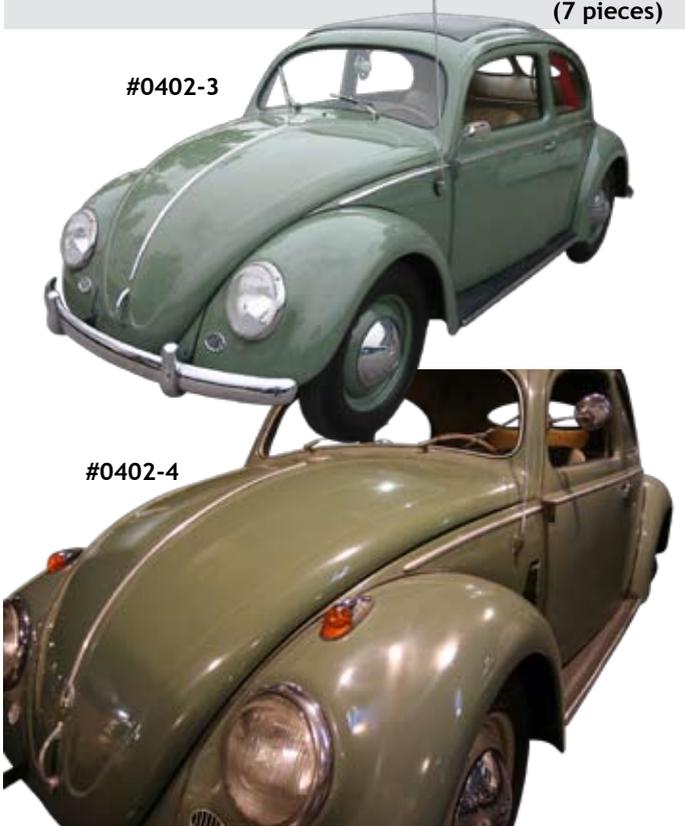
These moulding sets are made to measure for split bugs. Like the running board moulding (BBT 0200-3) we have chosen for brushed aluminium, so it isn't polished because originally these mouldings weren't polished either. The difference between the 2 models is the length of the front hood moulding. As from the beginning of 1951 an emblem has been placed above the door handle, which made that a shorter moulding was used. Sold a set for 1 car. Stock already available.

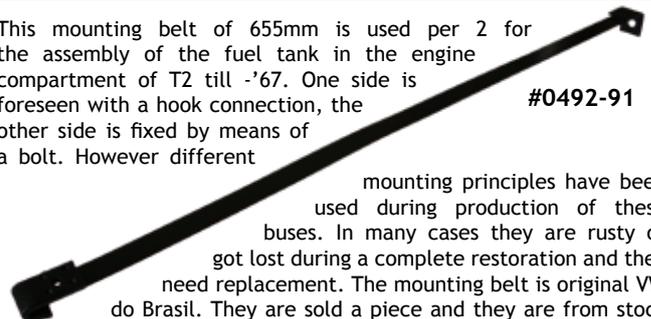
#0492-91

This mounting belt of 655mm is used per 2 for the assembly of the fuel tank in the engine compartment of T2 till -'67. One side is foreseen with a hook connection, the other side is fixed by means of a bolt. However different

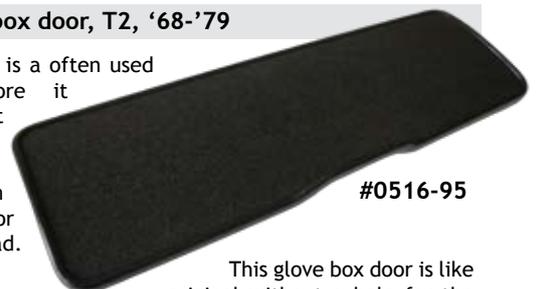
#0516-95

This glove box door is a often used part and therefore it breaks down quiet frequently. After many years of use the spring, which keeps the door upwards will be bad.

This glove box door is like original without a hole for the lock, as not everyone has a lock. Sold a piece and stock is already available.

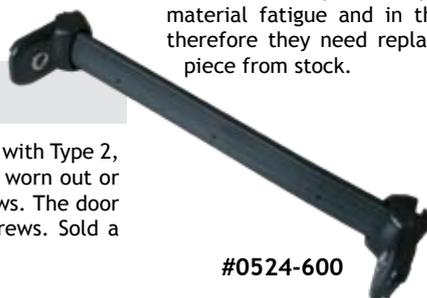
#0524-600

This door handle is mounted at the inside of the cab door with Type 2, '68-'79. Due to frequent use they are most of the times worn out or have broken off. They can be placed quickly with 2 screws. The door handle is completely in black and delivered without screws. Sold a piece and already some in stock.

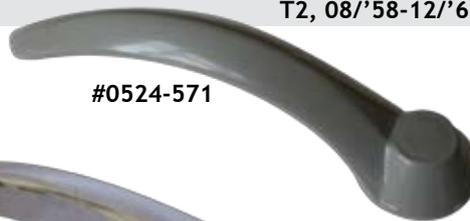
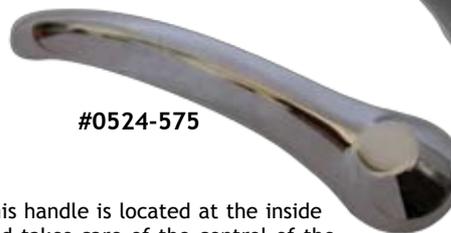
This handle is located at the inside of the front doors and takes care of the control of the locking system of the door. In many case they are damaged due to frequent use, material fatigue and in the case of the chrome by corrosion and therefore they need replacement. As from now we deliver them a piece from stock.

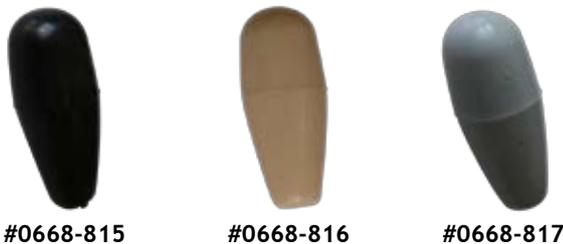
This button is located on the lever of the direction indicator switch with T2, 03/'55-07/'65, T1, 10/'52-07/'60 and they make sure that the switch is easy to use. If you install a new switch, it's logical to mount also a new button. The old button needs probably to be replaced because it's too old. It's quiet possible that you miss only the button, but that the original switch is still working. Now you can replace the button only, and recover the original switch. We deliver them in 3 colours, black (BBT 0668-815), ivory (BBT 0668-816) and grey (BBT 0668-817). These buttons are available a piece from stock.

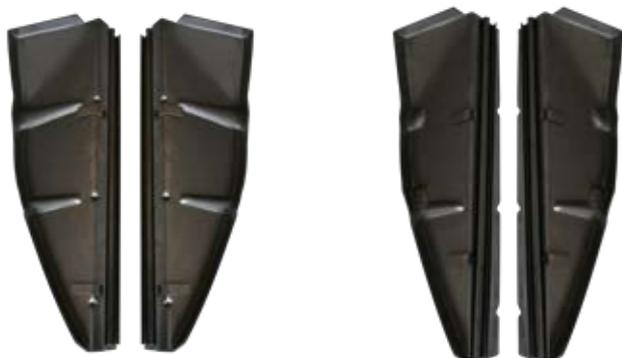
#0888-050 #0888-051 #0888-070 #0888-071

These panels can be found in the engine side left and right of the engine against the inner fender. They take care of the connection of the body against the engine block, so that no dirt and dust can get into the engine compartment. These panels strengthen also the rear part of our beloved VW bug. As from now we can deliver them with the correct profile and fit in an excellent quality a piece from stock. Model '60-'67 will follow...

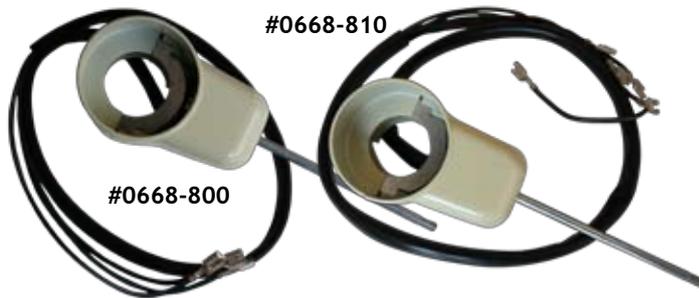
This indicator switch can be found on the steering column just below the steering wheel and is used for the manoeuvre of the wipers with buses from the years 03/'55-07/'65. The type with 3 connecting wires (BBT 0668-800) is used for types till 05/'60. From 08/'57 there is however also the 6 wires finish (BBT 0668-810) in use on versions for export. Due to frequent use the authentic switch can fail which can lead to the non-functioning of the indicator switches, which we certainly can't miss in the actual traffic. The indicator switch button is available separately (BBT 0668-815/816/817). It is sold a piece and already available from stock.

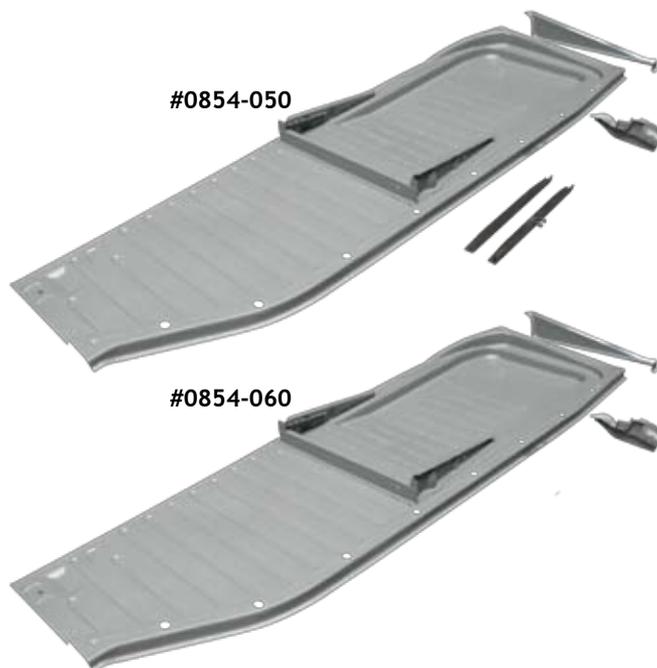
These floor plates are developed to comply to the actual demand for quality products. They are made from 1.20mm thick steel, like they were made originally by Volkswagen. In order to facilitate transportation, the jacking point and the rear part haven't been assembled and are delivered loose. Sold a piece per side. Stock already available.

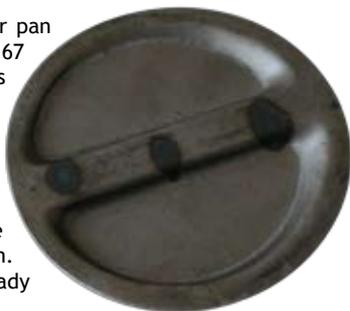
#0890-136

This cap is assembled in the floor pan of the cabin with Type 2, '59-'67 (BBT 0890-135) and it facilitates the refilling of the brake fluid reservoir. If you replace the floor pan, you need normally also to replace the cap. Most of the times it is broken or lost and needs replacement. That's why we have taken them into our program. Sold a piece and stock is already available.

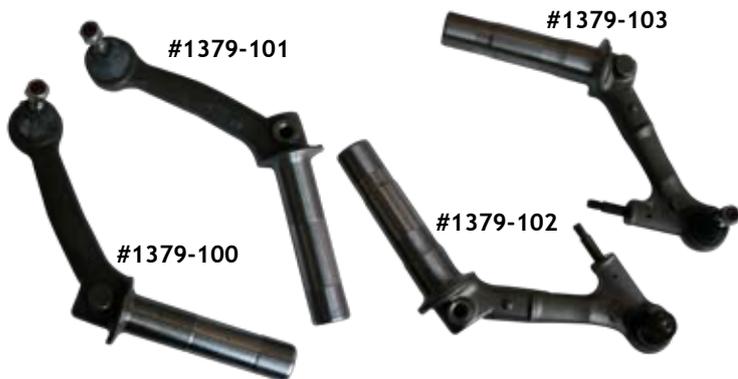
These new torsion arms are Volkswagen original and they leave the VW factory mounted with an original suspension ball joint! Second hands become rather scarce and are mostly worn out, resulting in inferior road-holding a part from extra damage to bearings and bushings and that also the suspension doesn't function properly with. Sold a piece and stock is already available.

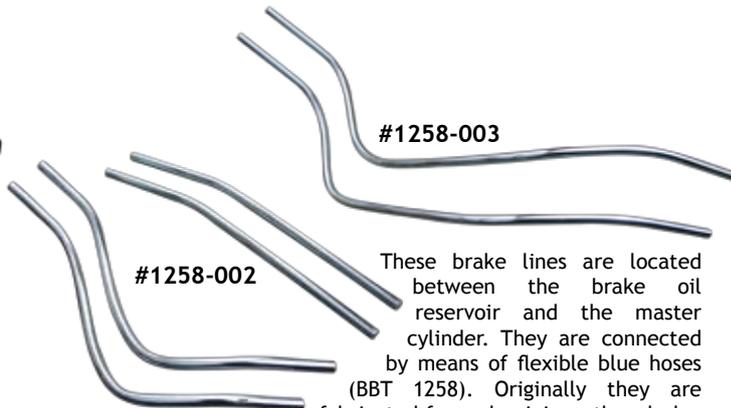
These brake lines are located between the brake oil reservoir and the master cylinder. They are connected by means of flexible blue hoses (BBT 1258). Originally they are fabricated from aluminium, though due to corrosion of the brake fluid and rust they are in many cases damaged or no longer suitable for the safe functioning of the brake system. As from now we deliver them from stock a set for 1 car.

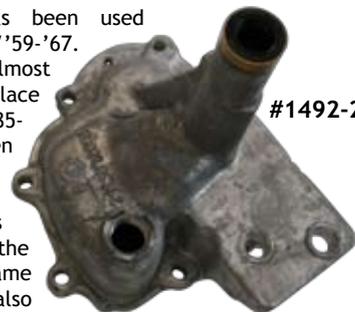
#1492-200

This transmission nose has been used originally with Type 2 from 07/'59-'67. The nose on itself won't be almost never bad, as long as you replace the suspension seal (BBT 1485-2) in time. This is used often during assembly of a younger type of gear box on a body till 1959. The advantage of it is that you don't need to adjust the body and you can use the same gear box support. They are also used when you wish to mount a type 1 gear box in a bus with the intention to eliminate the reduction box. It is absolutely necessary to use this nose, because when you keep the nose of the Type 1 gear box, you won't be able to mount the shift rod due to the difference in height with the control shaft of the gear box. They are delivered inclusive the seal (BBT 1492). Due to the increasing demand after this product, we have it yet new in our program. Sold a piece and stock is already available.

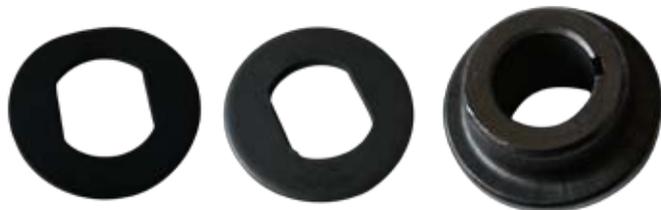
These spare parts are used for the assembly of the cooling fan on the shaft of the dynamo/alternator to aim the cooling of the engine block. These parts must be in an impeccable condition to prevent that the cooling fan comes loose, resulting the failure of the cooling. As from now we can deliver them original from stock. Sold a piece.

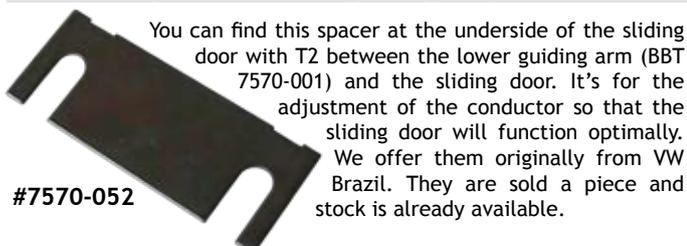
#7570-052

You can find this spacer at the underside of the sliding door with T2 between the lower guiding arm (BBT 7570-001) and the sliding door. It's for the adjustment of the conductor so that the sliding door will function optimally. We offer them originally from VW Brazil. They are sold a piece and stock is already available.

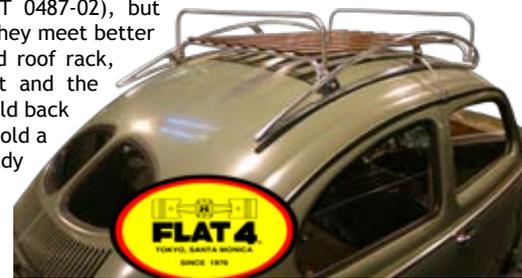
Flat 4 has assumed the rights from the Spanish manufacturer of the original Airstreme roof rack. At first sight they resemble our 'Vintage Speed' roof racks (BBT 0487-02), but the difference is that they meet better the demands of a good roof rack, as arches at the front and the rear of the roof rack hold back the luggage. They are sold a piece and stock is already available.
