IN THIS EDITION

NEW PRODUCTS

N°44, OCTOBER 2009

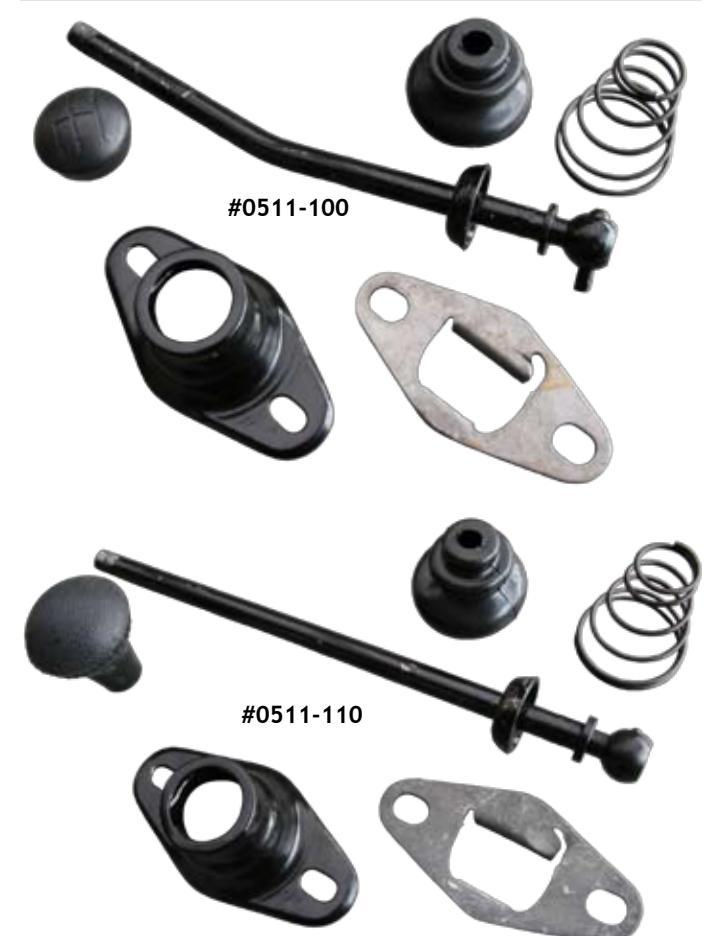
#0511-100 Shifter set, T1, KG, '68-#0511-110 Shifter set, T1, KG, '58-'67

Due to frequent demand after a solid replacement for the original shifter, we've been looking for a good alternative. With these items we've found a good although not completely exact substitution. The model for T1 and Karmann Ghia '58-'67 (BBT 0511-100) is a bent execution although it is shorter than the authentic one and has a 12mm screw thread for the assembly of the shift knob. This last one is not the exact finish, but it shows though the correct shift pattern. The younger model (BBT 0511-110) has a somewhat longer shaft (292mm) and a shift knob resembling the one used on Type 3. For this last adjustment we can however deliver from stock the correct shift knob as on our item (BBT 0514-075). The shifter is sold as a complete set with reverse lockout plate (BBT 0510-001), spring, shift bar, foot, seal and knob. As from now we deliver both shifters from stock in a set.

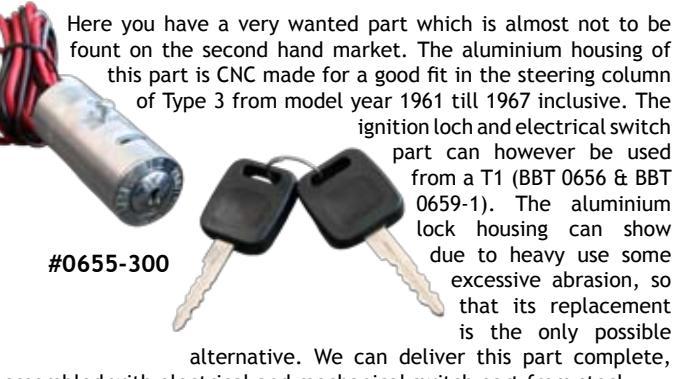
#0655-300 Ignition/steering lock, Type 3, '61-'67

assembled with electrical and mechanical switch part from stock.

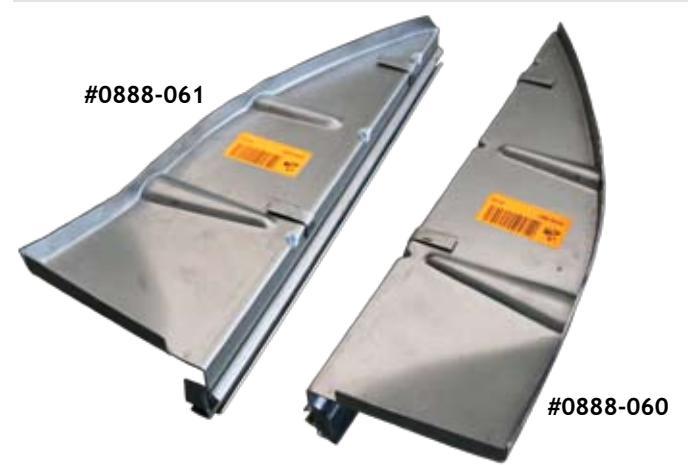
#0888-060 Engine side panel, left, T1, '61-'66 #0888-061 Engine side panel, right, T1, '61-'66

These side panels can be found in the engine compartment left and right from the engine against the inner wing. They take care of the connection of the body against the engine block, so that no dirt and dust can get into the engine compartment. Furthermore these plates strengthen the back side of our beloved VW bug. As from now we can deliver these panels with the correct profiles and fit in a excellent quality. We had already model -'60 BBT (0888-050/051) and '67-'74 (BBT 0888-070/071)in our program. The model for '61-'67 is now available a piece from stock.

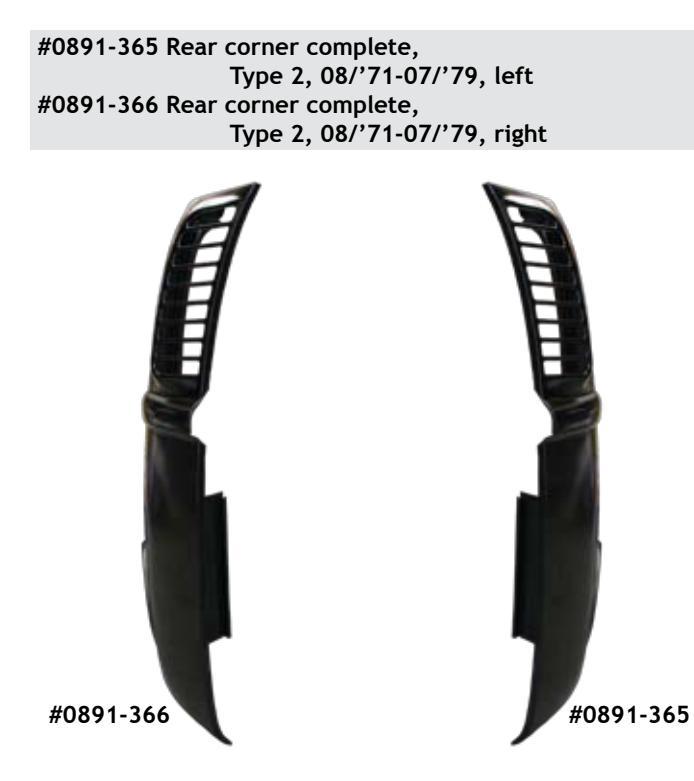
These rear corner are complete from the underside till the rain gutter with facilities for the big taillight and ventilation grill. They are original from Volkswagen Brazil and they fit very well. All other imitations are not what they should be. Sold a piece and already stock available. #0890-185 A-post bottom repair, T2, -'67, L #0890-186 A-post bottom repair, T2, -'67, R

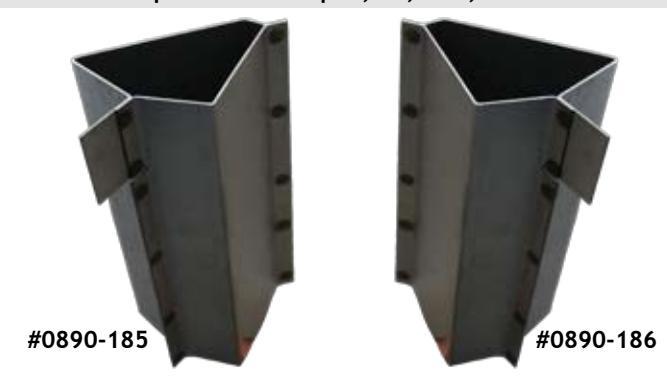
As a result from the increasing demand BBT has taken these repair parts for you into their program. In the past they were a part of "Inner front panel, T2, -'67" (BBT 0891-18) though they are no longer foreseen of these A-post parts. The fit and finishing of BBT 0890-18 has improved considerably. The repair parts can be found near to the A-post under the floor plate with T2 till model year 1967. In many cases these parts have been seriously affected by rust and a replacement is the only solutions. We offer them as from now a piece and per side from stock.

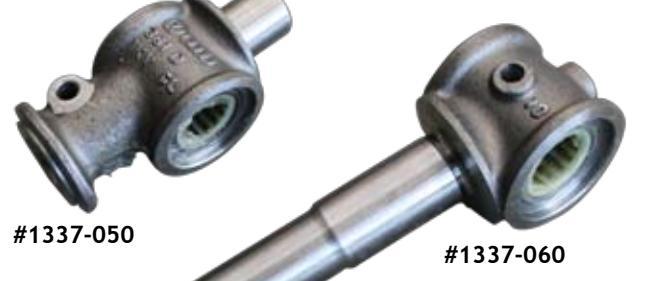
#1337-050 King pin lower with needle bearing, Type 2, 08/'63-'67 #1337-060 King pin upper with needle bearing, Type 2, 08/'63-'67

As from now we can deliver the king pins, which are much asked for, (lower and upper) original from Volkswagen. They

are important parts during revision of the spindles. They are used on buses starting from ch. 1 144 282 (08/63) till end split bus 1967. Together with BBT #1337 (link pin set) we can give the spindles now a thorough revision, which will benefit the security considerably. Both king pins are already foreseen with a needle bearing. Sold a piece and stock is already available.

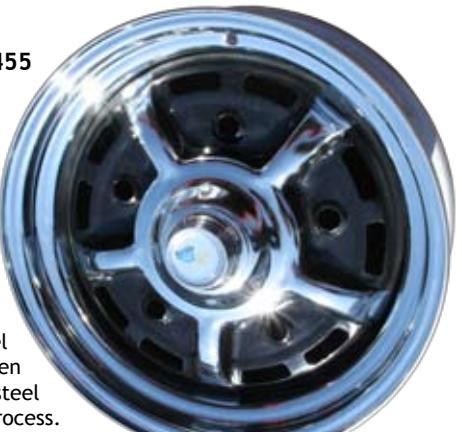
#2598-455 BBT 5-lug Sprintstar wheel (4.5x15) grey/black #2598-555 BBT 5-lug Sprintstar wheel (5.5x15) grey/black #2599-455 BBT 5-lug Sprintstar wheel (4.5x15)

After 3 years of development BBT launches the original style sprintstar from the sixties. Our steel sprintstars have been stamped out of real steel in a 6-step stamping process. Detail and quality are second to none. The chrome version is tested

according to international automotive standards in a 240hrs salt spray test. This is a real sixties revival without compromises. Available in grey or chrome in 4.5 and 5.5 by 15.

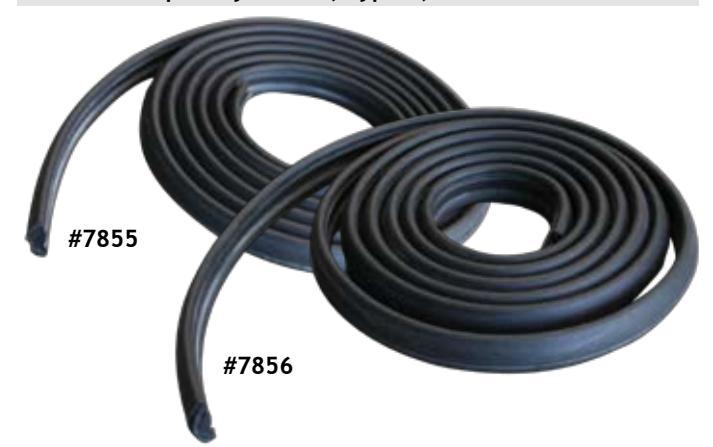
#7855 Seal spare tyre bowl, Type 3, '61-'69 #7856 Seal spare tyre bowl, Type 3, '70-'73

This seal is possibly unknown to many Type 3 owners just due to the fact that they are missing on many Type 3 vehicles. Principally it can be found between the removable spare tyre bowl and the recess in the nose for the spare tyre bowl. It has several functions. On the one side it prevents that splashing water gets into the spare tyre hole and prevents friction between these 2 metallic parts. Available in 2 lengths, till 07/'69 it was 179cm long, from model year 1970 the form of the spare tyre bowl has been changed and the length was reduced to 160 cm. Available a piece from stock.
